# Utah Hail 2026: One Afternoon in Davis County

The September 18 supercell, what the record actually shows, and the six weeks roofers have before the snow.

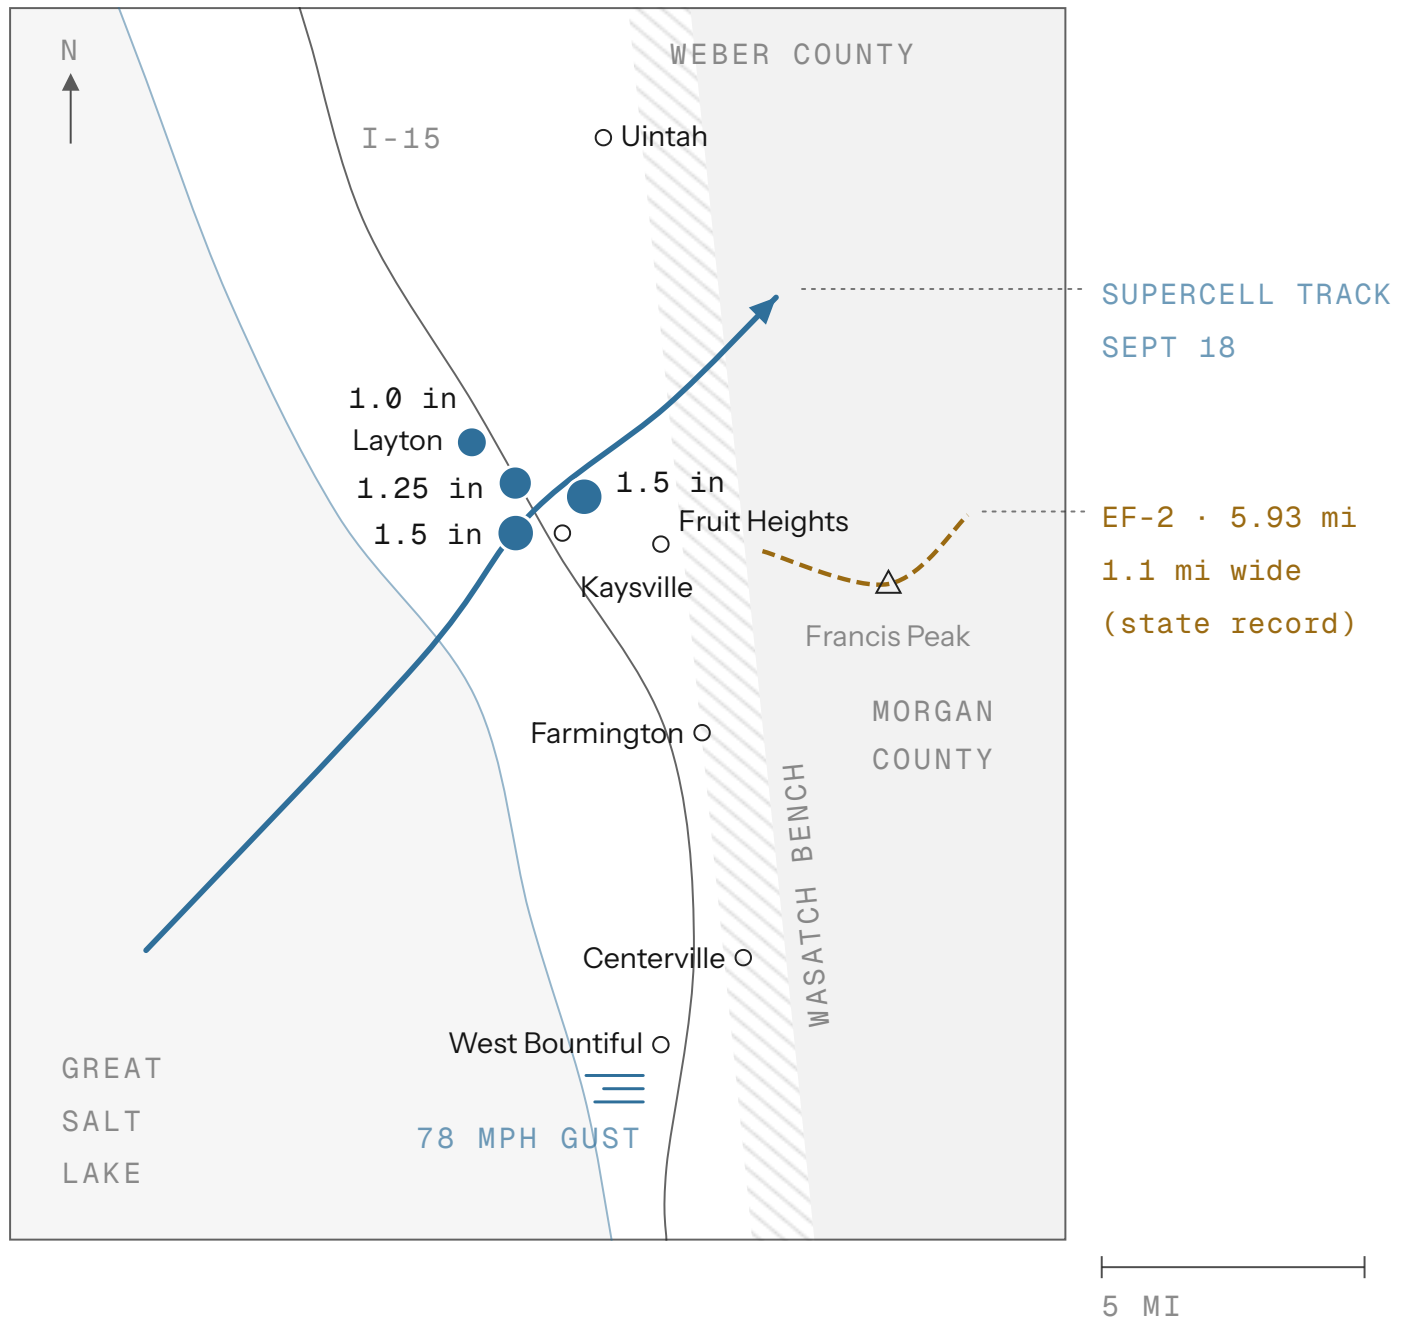
- SUPERCCELL TRACK    - - - - - TORNADO PATH · EF-2 · 5.93 MI · 1.1 MI WIDE (STATE RECORD)
- NWS HAIL REPORT
- ① 1.0 in · Layton    ② 1.25 in · measured    ③ 1.5 in · Kaysville, west of I-15
- ④ 1.5 in · Spotter Network

Schematic, not a radar overlay: the storm track and tornado path are drawn from the reports cited in this article, and the hail pips are NWS-accepted public reports; pips whose report names no street are placed within the Kaysville–Layton corridor approximately.

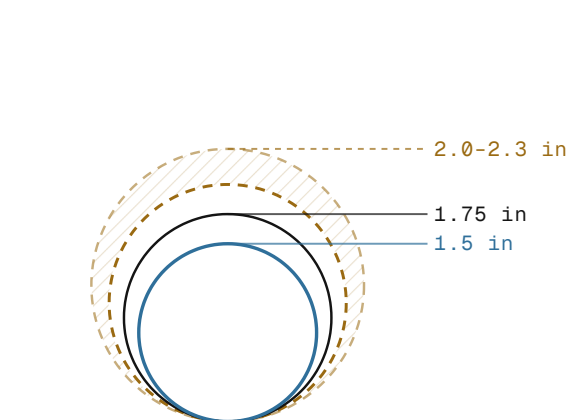
The gap between what the NWS logged on September 18 (ping-pong, 1.5 in), what every homeowner with a phone called it (golf ball, 1.75 in) and what the radar products say (2 to 2.3 in) is normal, and it is exactly the gap an adjuster will exploit. Take photos next to a tape measure.

Pick your witness. The adjuster will pick the first one. Drawn to one scale.

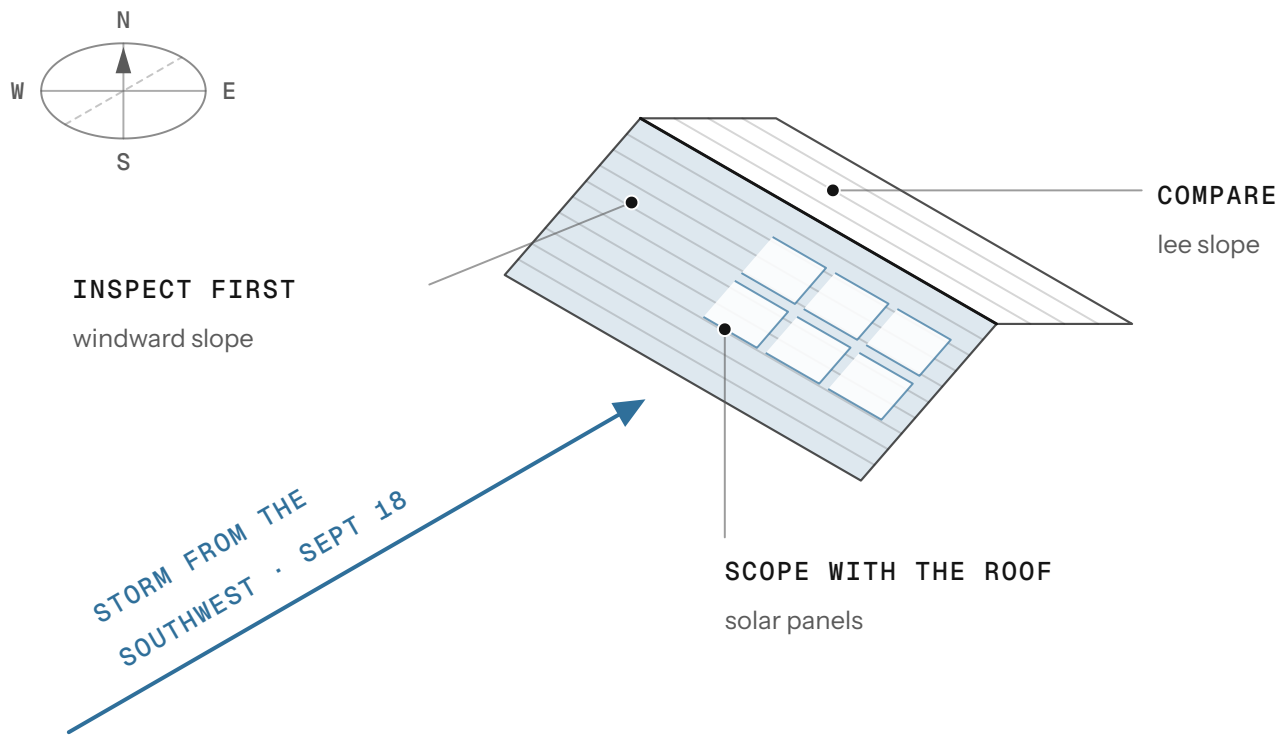
Hail with wind behind it marks the storm-facing slope first; the lee slope is the control. Solar panels are scoped with the roof or the claim misses them.

| ROOF OR COMPONENT | COMMON IN | WHAT TO LOOK FOR AFTER 2026 | WHAT NOT TO ASSUME |
| <b>Architectural asphalt</b> | Most of Davis, Weber and Utah County subdivisions | Bruises you can feel on the windward slopes, fractured mat under the granules, creased or lifted tabs from the 50 to 78 mph wind; compare with wear on the lee slopes | Granule loss alone is not hail; a 1.5 in event does not fail every slope, and the lee side may be fine |
| <b>3-tab asphalt and older laminates</b> | Holladay, Millcreek, Kaysville, Farmington, Bountiful older housing | Random hits with exposed mat, cracked tabs, broken seal strips; June 25 damage in Salt Lake County has had a summer of UV on top of it | Age makes replacement likely, not automatic |
| <b>Class 4 impact-rated asphalt</b> | Newer builds and prior-claim replacements | Cosmetic marking, occasional fracture; identify the actual product before telling an owner it survived | UL 2218 Class 4 is a 2 in steel-ball lab test, not a field guarantee |
| <b>Standing-seam and exposed-fastener metal</b> | Wasatch Back, Mountain Green, Morgan, newer high-end homes | Dents on panels, ribs, vents and flashing; broken coatings or opened seams are the functional finds | Most policies treat metal dents as cosmetic; a dent is not a leak and not a panel |
| <b>Synthetic shake and real cedar</b> | Park City, Midway, older Wasatch Back | Split or displaced shakes, cracked synthetic pieces, lost fasteners from wind | Cedar splits from age and weather too; attribution needs a pattern, not one shake |
| <b>Rooftop solar</b> | Davis and Salt Lake counties especially | Cracked glass, visible cell damage, output drop; the Kaysville homeowner on KSL reported both cracked and non-functioning panels | Microcracks need an installer's test, not a roofer's eye; scope panels with the roof or the claim will miss them |
| <b>Flat commercial: TPO, EPDM, modified bitumen</b> | Layton, Ogden, Salt Lake retail and warehouse | Punctures over hard substrate, split seams, crushed insulation, interior water (the Layton Men's Wearhouse is the public example) | Blisters and ponding are not hail evidence; identify the assembly before scoping |

| ROOF OR COMPONENT | COMMON IN | WHAT TO LOOK FOR AFTER 2026 | WHAT NOT TO ASSUME |
|---|---|---|---|
| Vents, gutters, skylights, siding, fences | Everywhere | Dented aluminum, cracked lenses, cracked vinyl fence (reported in Kaysville), siding on the storm-facing wall | Dents corroborate hail but do not measure it; each item is scoped on its own |
